Manhole Inspection Summary

Manhole # S09OO_027MH

Location Address: **3300 HILTON ST** Cross Street: **PIEDMONT AVE**

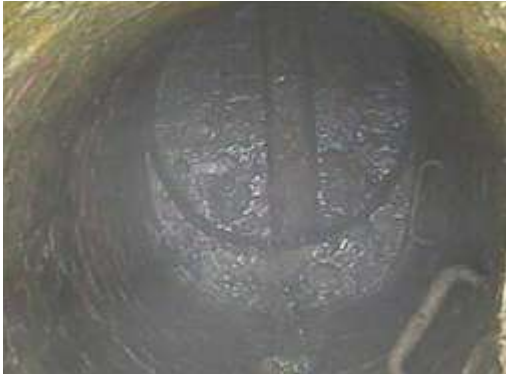
Defect 1

Steps Count: **3** Missing: **0** ☒ **Corroded**

CORRODED STEPS

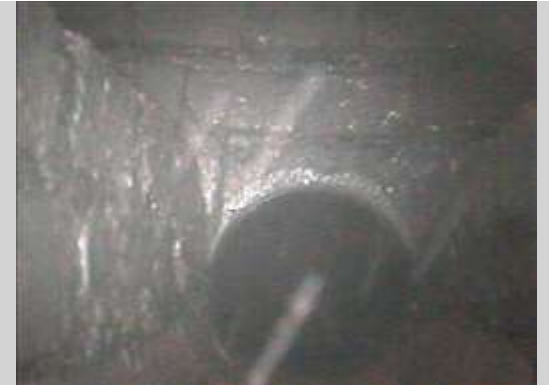
12 O'Clock Outflow

8 in. Circular Gravity Sewer
Pipe Out @ 12 O'Clock

Pipe Height: (in.) Direct
Pipe Material: **Clay** ☐ Pipe Lined
Invert Depth: **9.06** (ft.) Flow Characteristics: **Fast**
Deposits: ☒ None ☐ Mud ☐ Sludge ☐ **Debris** ☐ Grease
Silt Depth: (in.) Deposits Extent:
Infiltration: **None** Pipe Seal Cond: **Sound**

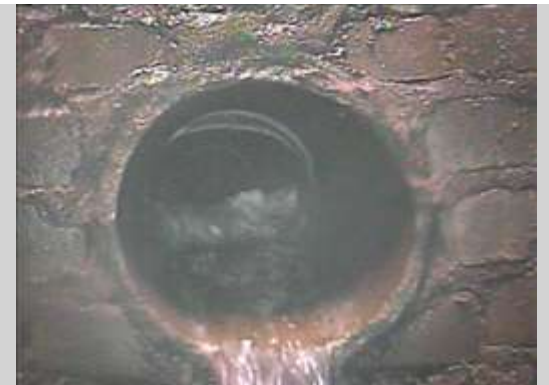
6 O'Clock Inflow

8 in. Circular Gravity Sewer
Pipe In @ 6 O'Clock

Pipe Height: (in.) Direct
Pipe Material: **Clay** ☐ Pipe Lined
Invert Depth: **5.02** (ft.) Flow Characteristics: **None**
Deposits: ☐ None ☐ Mud ☐ Sludge ☒ **Debris** ☐ Grease
Silt Depth: **2** (in.) Deposits Extent: **Light**
Infiltration: **None** Pipe Seal Cond: **Sound**

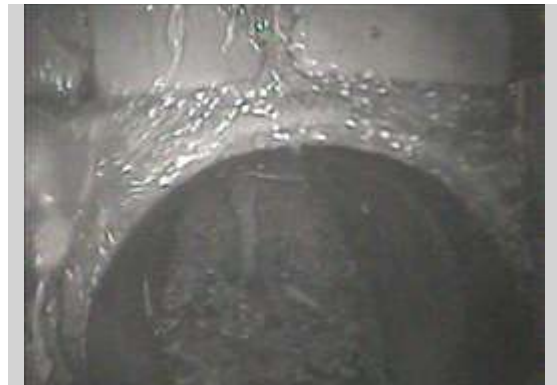
Drop In @ 6 O'Clock

Drop: **Outside Direct**
Angled: Reading: (ft.)
Inv Depth: **8.94** (ft.)
Drop Condition: **Clogged**
